## U.S. Navy Successfully Offloads Nearly Two Million Gallons of Oil Threatening the Ulithi Atoll

The USS MISSISSINEWA (AO-59), a 553-foot long, 25,425-ton Navy oil tanker.

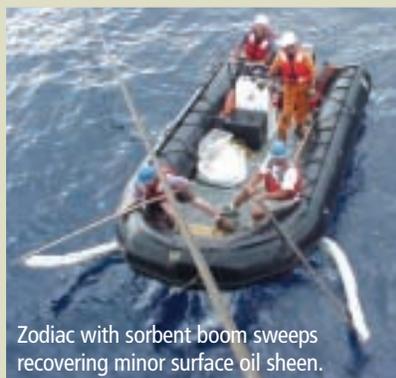
Zodiac with sorbent boom sweeps recovering minor surface oil sheen.

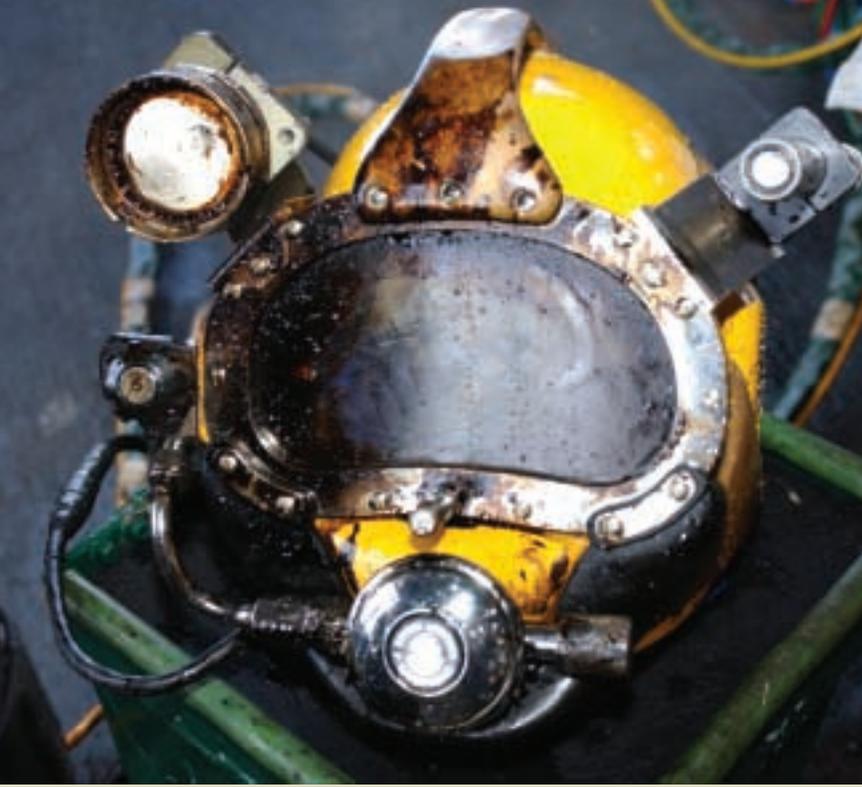
Navy Mk 21 hardhat with helmet-mounted video camera and light—following dive in #4 starboard tank. (Mk 21 is the Mark 21 Mod 1 Underwater Breathing Apparatus diving system.)

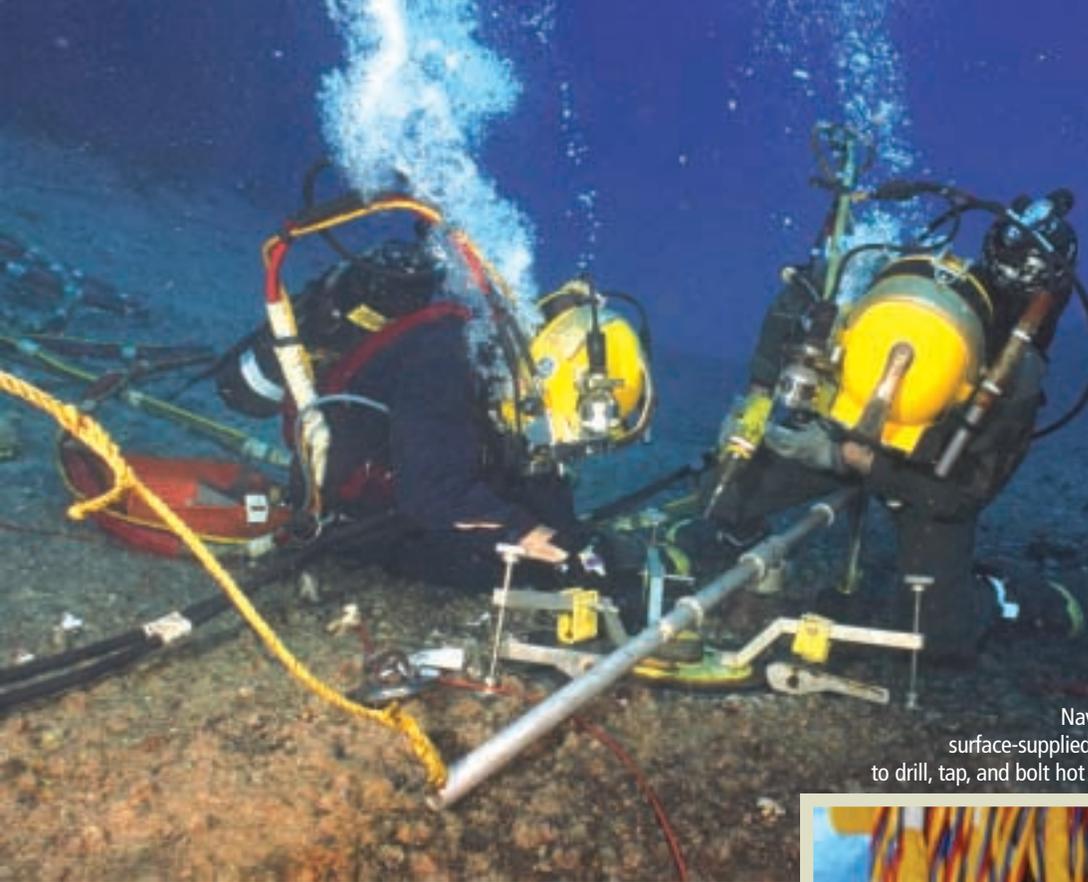
Navy divers in Mk 21 surface-supplied air rigs preparing to drill, tap, and bolt hot tap flange to hull.

The hot tap operation involved cutting 3.5-inch holes in the hull of the ship at top locations on the tanks, using a rotating cutter device. Once this hole was cut, a valve over the hole was secured and a hose attached to the submerged pump replaces the cutter. The valve was then opened,

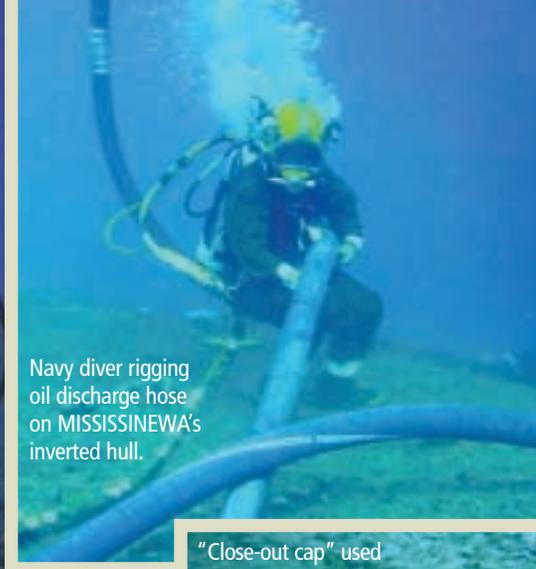
Navy diver rigging oil discharge hose on MISSISSINEWA's inverted hull.

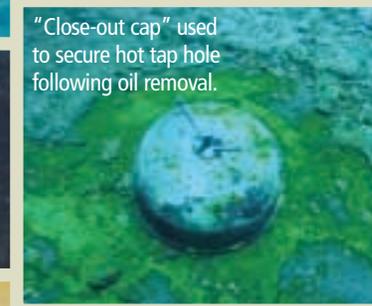
"Close-out cap" used to secure hot tap hole following oil removal.

The hot tapping began with the tanks containing the greatest volume of oil and involved a series of ‘pumping and settling’ cycles to strip the tanks. The oil was pumped from the tanks at a rate of up to 450 gallons per minute. Once water was detected at a sampling port, initial high volume pumping was replaced by a series of alternating settling and low volume “stripping” pump sequences to ensure removal of all accessible oil. After all the accessible oil had been removed, the divers then removed the valves and permanently sealed the access holes.

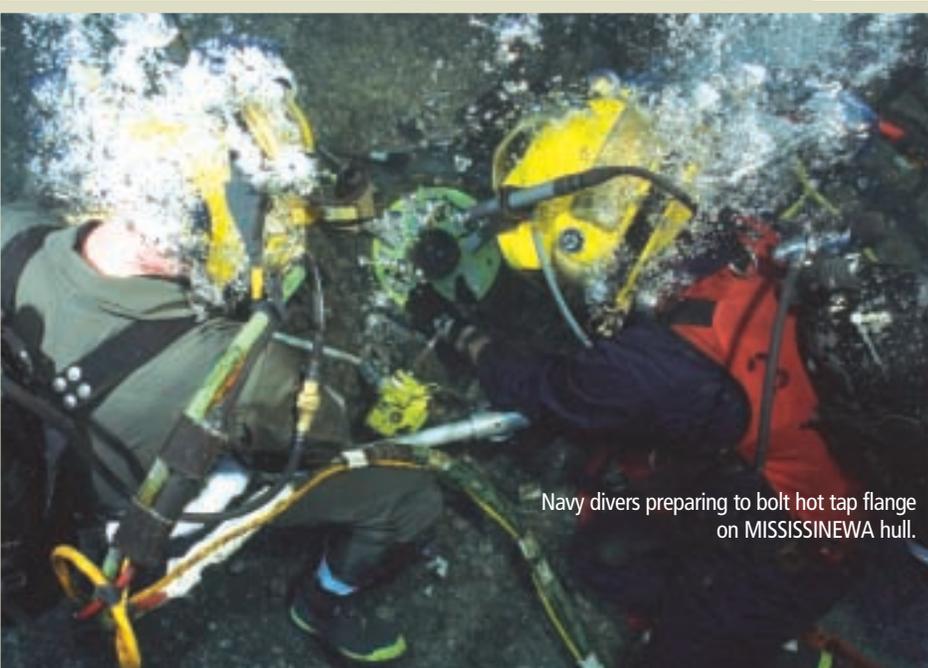
Navy divers preparing to bolt hot tap flange on MISSISSINEWA hull.

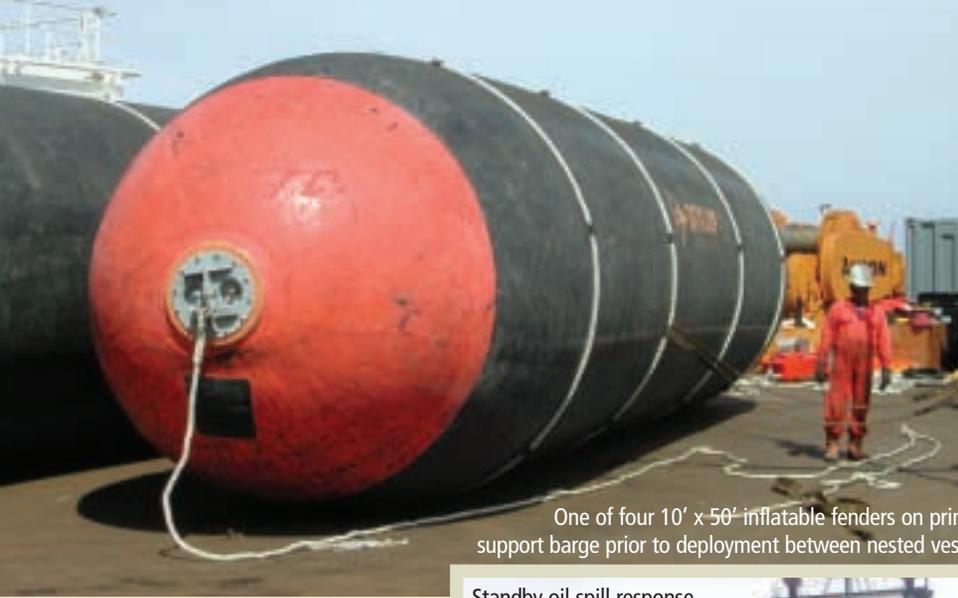
One of four 10' x 50' inflatable fenders on primary support barge prior to deployment between nested vessels.

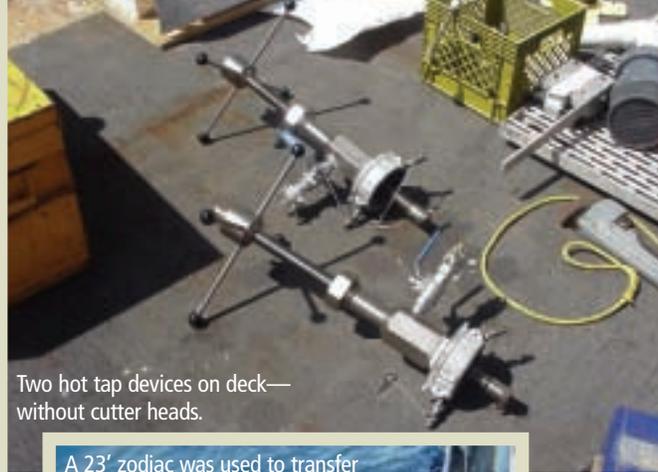
Two hot tap devices on deck—without cutter heads.

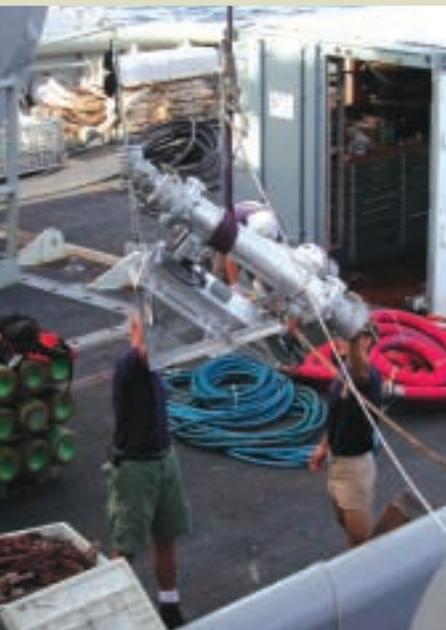
Hot tap and pumping equipment being transferred from the primary support barge to USS Salvor alongside.

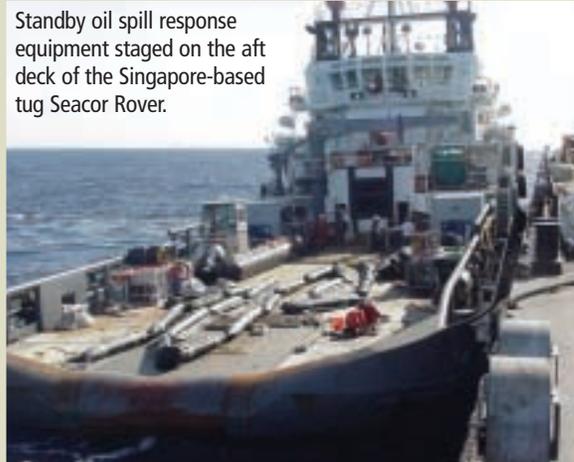
Standby oil spill response equipment staged on the aft deck of the Singapore-based tug Seacor Rover.
